## CLAPHAM COMMON

Clapham Common Nov 2021.Docx

This report is intended to supplement the more comprehensive assessment of conditions in the 'Events' area of Clapham Common following a previous visit in August. The site was examined on 17 November 2021.

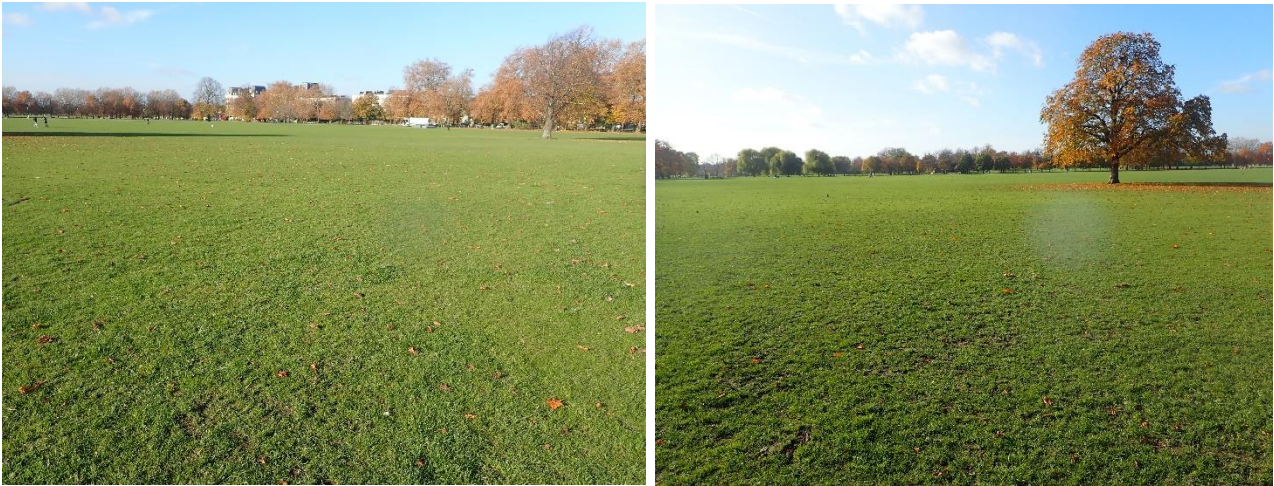
As would be expected, grass growth and establishment had continued over the months since the previous examination of the site. In many places, notably those unaffected by the earlier events or more recent activities, a reasonably full ground cover had developed.

**Figure 2-1 General appearance of ground cover to the western side of the event area**

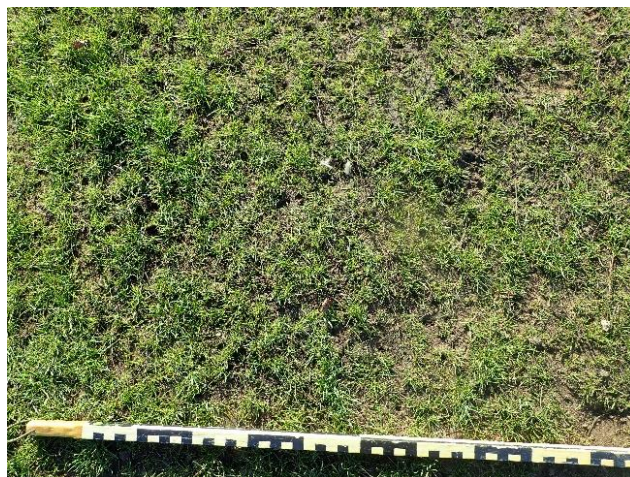
A general observation, however, was that the grass growth was nowhere especially vigorous, except possibly along the eastern boundary where the soil was substantially amended during the single pipe drain installation.

**Figure 2-2 Typical appearance of sward at eastern end of event site**

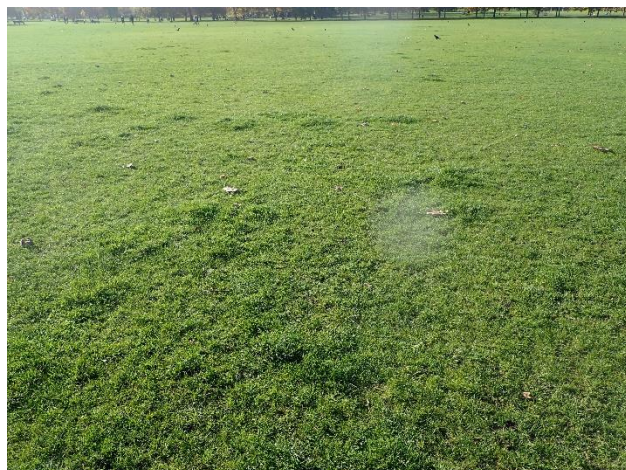
Evidence of a generally slow growth rate could be seen in the localised stimulation of growth associated, most probably, with animal deposits and which contrasted with the extent of growth taking place around these instances.

**Figure 2-3 Localised stimulation of growth associated with animal droppings**

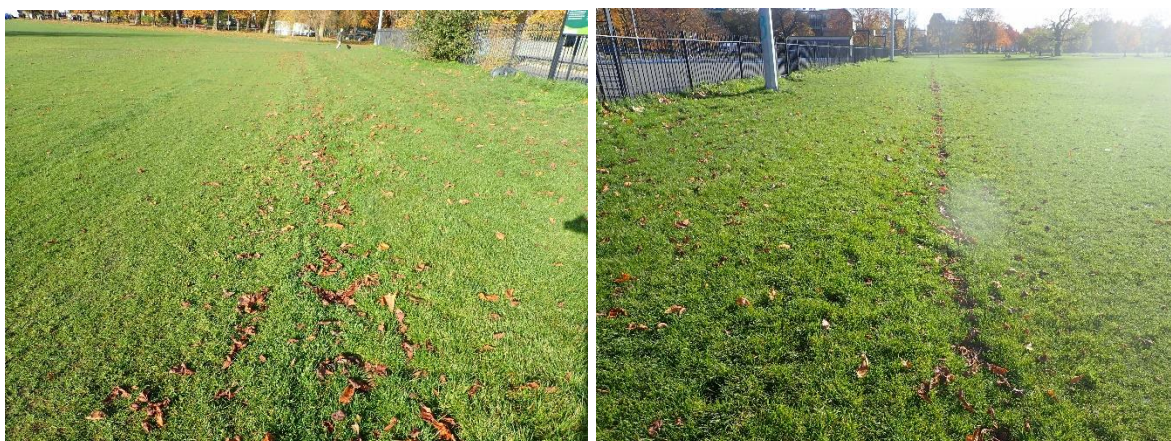
Along the eastern boundary, the altered topography, and the proximity to the fence, may have prevented this area from being mown as frequently as elsewhere or with the same equipment.

**Figure 2-4 Longer and more vigorous growth along the eastern boundary**

Certainly the sward height was significantly longer here than across the wider event area and a fuller ground cover had come about. A similar phenomenon was noted in areas under or close to trees where mowing is rarely, if ever, carried out.

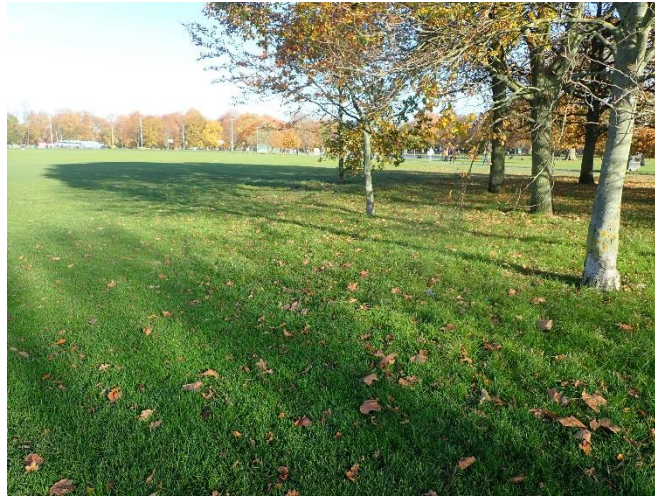
**Figure 2-5 Longer grass in areas below trees left unmown for longer periods**

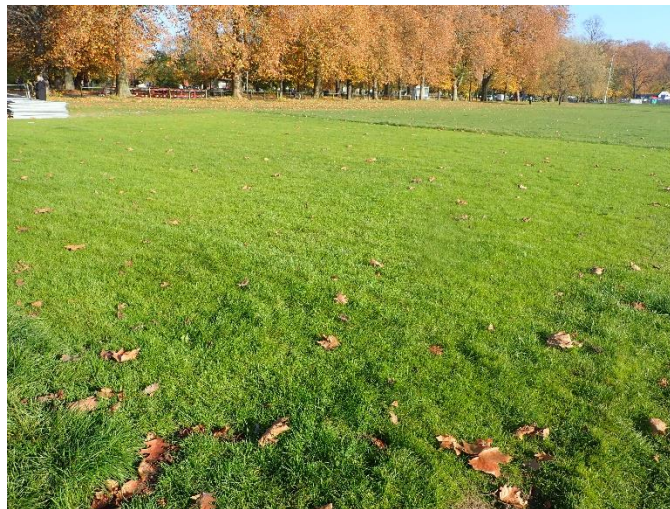
In the former compound and access area, substantial grass re-establishment had been achieved in an area yet to be re-introduced to the general mowing regime.

**Figure 2-6 Grass re-establishment in access area**

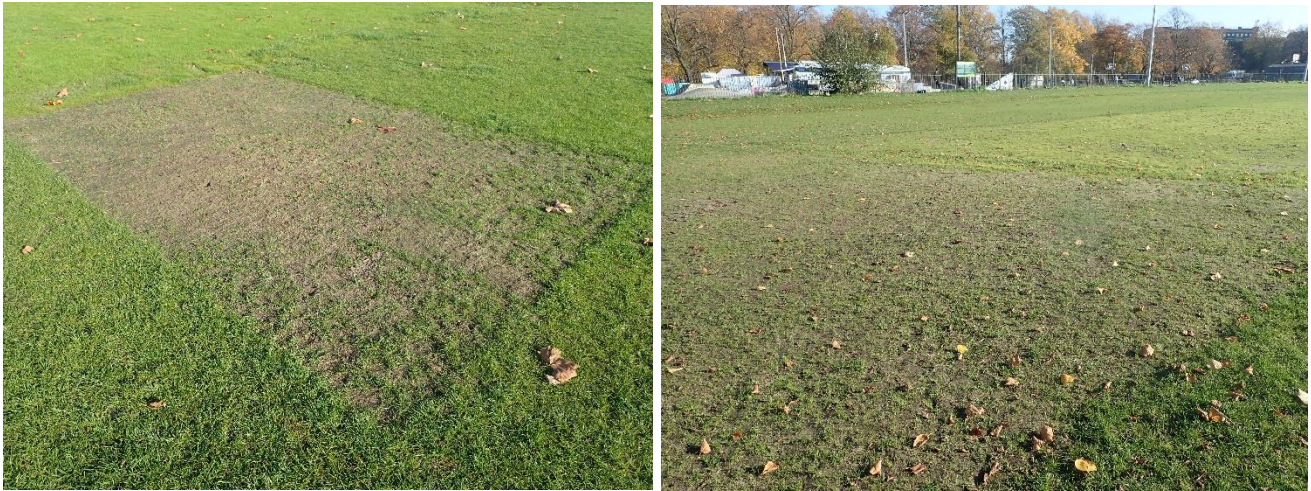
A few areas of thin, although not quite bare, ground persisted. In these places, formerly denuded of all grass cover and the sites of particular event installations, establishment from newly-incorporated seed appeared to have taken place slightly more slowly than elsewhere.

**Figure 2-7 Examples of persistently thinner ground cover in event installation areas**

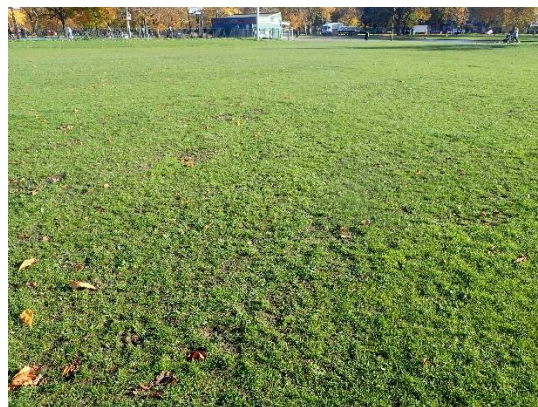
In the heavily used central section of the eastern side of the event area ground cover recovery had been generally successful but was still in need of filling out, a process likely to be achieved by encouraging more substantial growth rather than be over-seeding.

**Figure 2-8 Central section of main event area to the east**

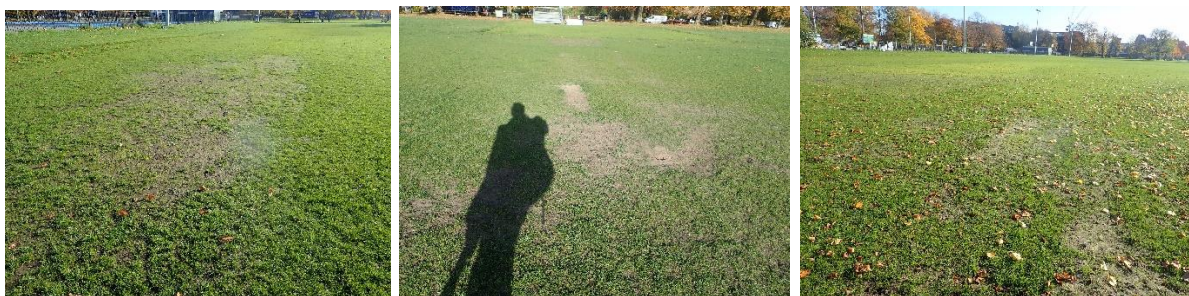
Only a few smaller areas remained completely bare, all of which were situated in the area of greatest event activity to the east.

**Figure 2-9 Persistent areas of bare ground**

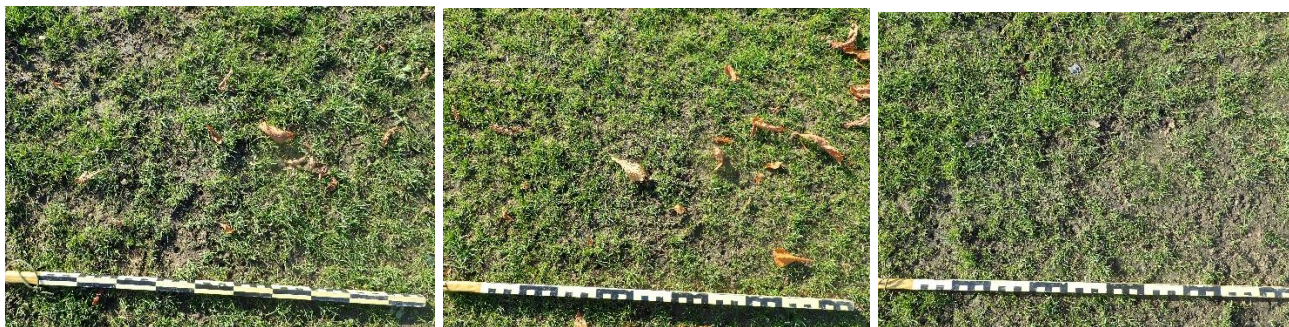
Generally to the west of the event area, there was abundant evidence of ‘casual’ play, probably football, having been played. Combined with the close mowing height, this had produced numerous areas of thin ground cover due to wear, though no obvious goal mouth areas could be identified.

**Figure 2-10 Football wear in close-mown sward**

The close mowing height adopted over the events area is applied because the same mower is used for the entire common, including the marked and formal football pitches to the west. Varying mowing heights on gang mowers of any kind is a time-consuming business and adjusting this on a regular basis would most certainly not be appropriate for application to such large areas. So, while the use of just one mower at the closest setting necessary may seem like an economically sound policy, this is not the case. The closer grass is cut, the more frequently it needs to be cut. If the standard for the entire site is to achieve football-type swards then, through the growing season, mowing will be necessary at least on a weekly basis. But the proportion of the Common given over to football is probably quite small and the entire event section is not given over to formal sport at all. If a mowing height of, say, 50 or 75 mm were to be adopted for areas not marked out for football, these would require mowing only once a fortnight or possibly even less frequently. Given the size of the areas concerned, this must represent a very considerable potential for achieving savings.

In practice, the approach might commence, in the first instance, with the incorporation of a mowing height of, I would say, 60 mm. This can only be accomplished using a rotary mower and would be appropriate across the entire Common, with the exception of the sports pitches and their surrounds where spectators will congregate. Note that the adoption of this mowing height on the eastern section will not only improve wear tolerance but should also quietly discourage the use of the area for casual organised sports as it has been noted takes place a good deal at present.

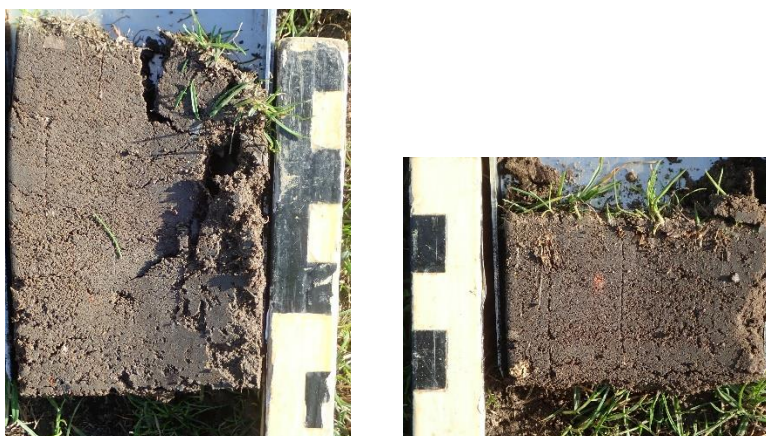
Examination of the soil profile of the eastern section showed the good texture of topsoil within the top 100 mm or so. There was little evidence of any sand amendment near the surface of this profile, however.

**Figure 2-11 Soil profile to the east (left) and west**

In the western section the profile was essentially the same but penetration by hand auger was more difficult, reflecting the greater amount of compaction in this area, largely unamended by the renovation work carried out to the east.

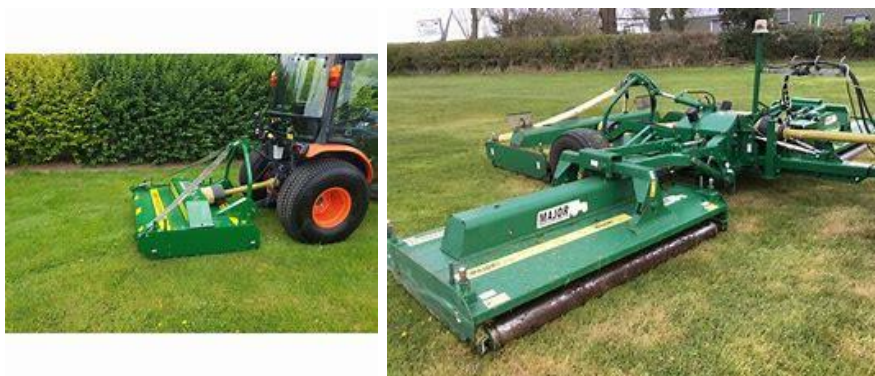
Rotary mowers able to accomplish this operation are standard equipment for most authorities. Given the generally very flat areas with which we are concerned, the most basic tractor-mounted, deck mowers would be suitable, an example of which is shown in Figure 3-1 as an individual deck and as a gang.

Figure 3-1 Individual and gang deck mowers

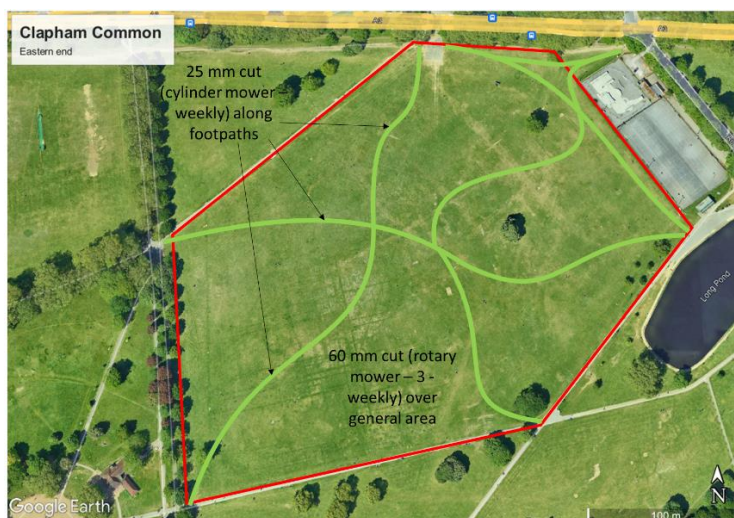
When the grass has reached a point, probably some time next spring, when the 60 mm cut needs to be carried out, it would be appropriate to identify where particular routes for pedestrians might, initially, be established. These would then need to be mown out using the football (cylinder) mower at 18 mm (though this should ideally be raised to 25 mm at least).

An example of how these paths might be set out in the first instance is shown in Figure 3-2.

Figure 3-2 Possible pattern of 25 mm and 60 mm cutting heights for forthcoming growing season

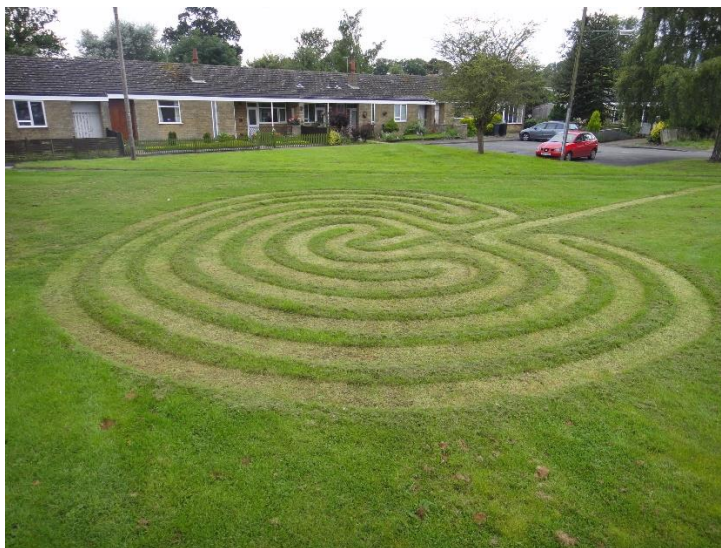
**Figure 3-3 Labyrinth incorporated into rotary mown public open space**

Taking the procedures one step further, opens up other possibilities the general public may appreciate. One such idea is that of incorporating designed features, a popular concept being that of the labyrinth. A small example, produced using a pedestrian rotary mower in 60 mm rotary mown turf on public open space, is shown in Figure 3-3. Such features can have spiritual significance for some (labyrinths are of historical interest and come in many designs) while for others they are simply attractive things to look at. They exist in this form only for the time someone is willing to create them and can be located anywhere.
