**Agrostis**  
SPORTS SURFACE CONSULTING

## CLAPHAM COMMON

This report is intended to provide a general appraisal of the condition, management requirements and likely tolerance of use of an area of Clapham Common. It is concerned with a substantial part of the park, generally situated towards its eastern end, and which has, over recent years, been used for numerous outdoor events. Those events have taken place during both the summer and winter and can be very damaging to the ground cover resulting in a reduction in the overall value of the site as public open space. Following these events it has been necessary to carry out extensive and intensive renovation works with the aim of restoring the former condition of the surface.

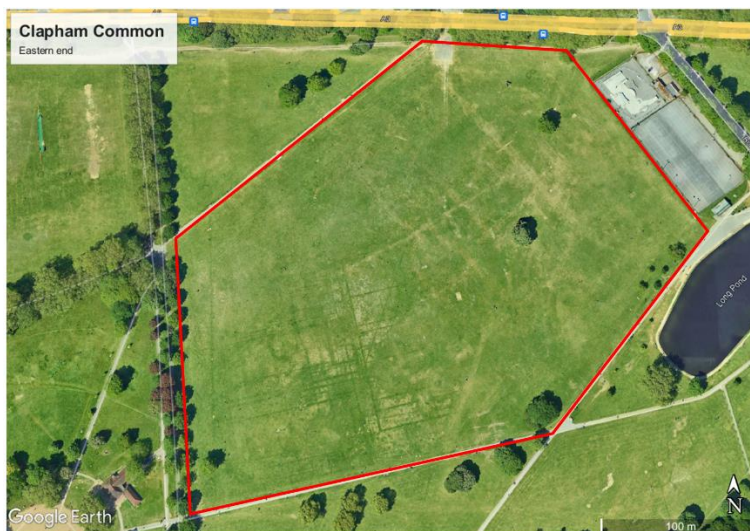
Figure 1-2 Approximate outline of Event area

The ‘Event area’, as we shall refer to it here, is shown in the same Google Earth imagery in Figure 1-2. This comprises approximately 77 000 m<sup>2</sup> (7.7 hectares, 19.0 acres, 0.077 km<sup>2</sup>).

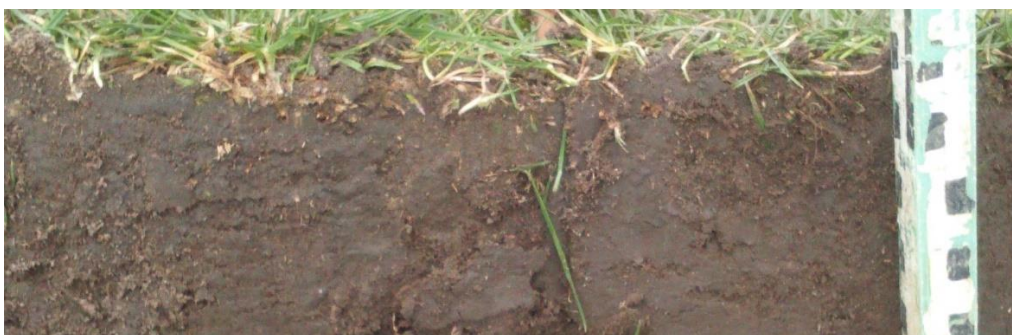
**Figure 2-1 Topsoil profile**

Excavation in 2017 revealed an organic, coarse sandy loam topsoil that extended to between 150 and 200 mm.

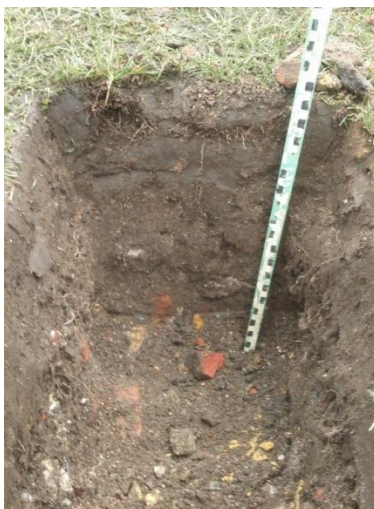
Figure 2-2 Soil profile

This overlay a subsoil composed of sand, gravel and clay intermingled with a great deal of landfill material including bricks, glass etc. Excavation by hand beyond around 400 mm was not possible due to the nature of this material.

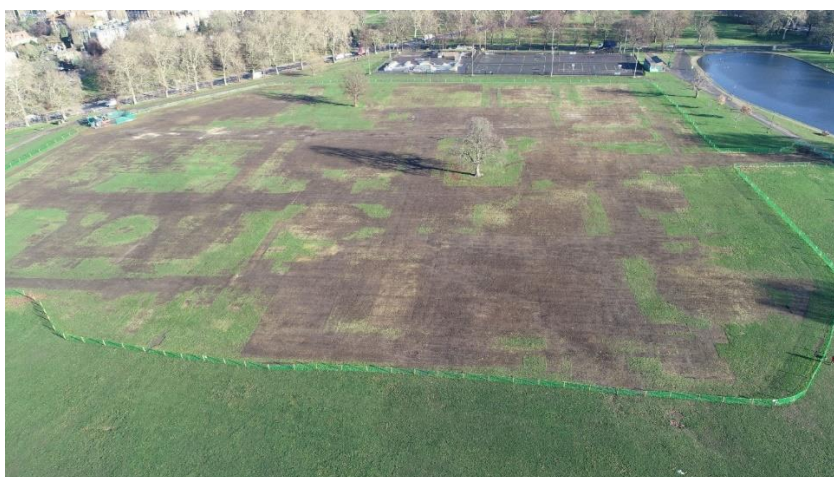
**Figure 2-3 Eastward view over the Event area, 17 January 2019**

A substantial loss of ground cover had been experienced following an event that took place over the winter of 2018/19. An aerial view of the Event area in January of 2019 is shown in Figure 2-3. This indicates perhaps 70 % loss of ground cover across the area.

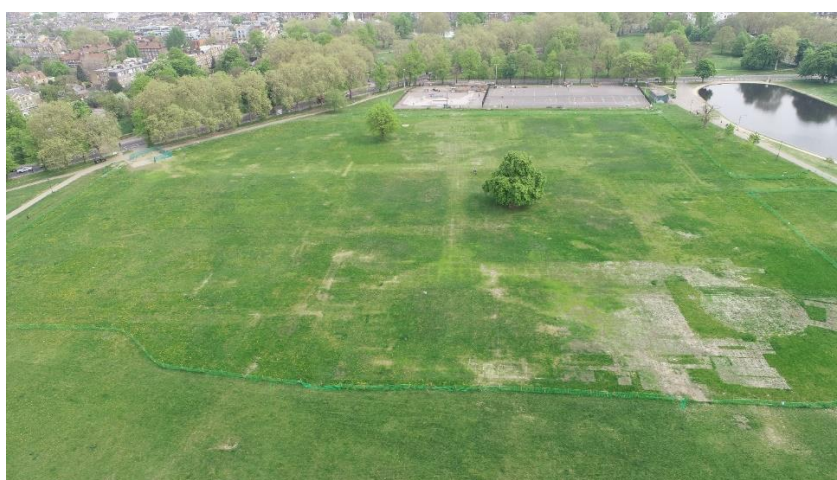
**Figure 2-4 Ground cover restoration by 27 April 2019**

By the end of the following April, renovation works had restored the ground cover to the extent shown in Figure 2-4.

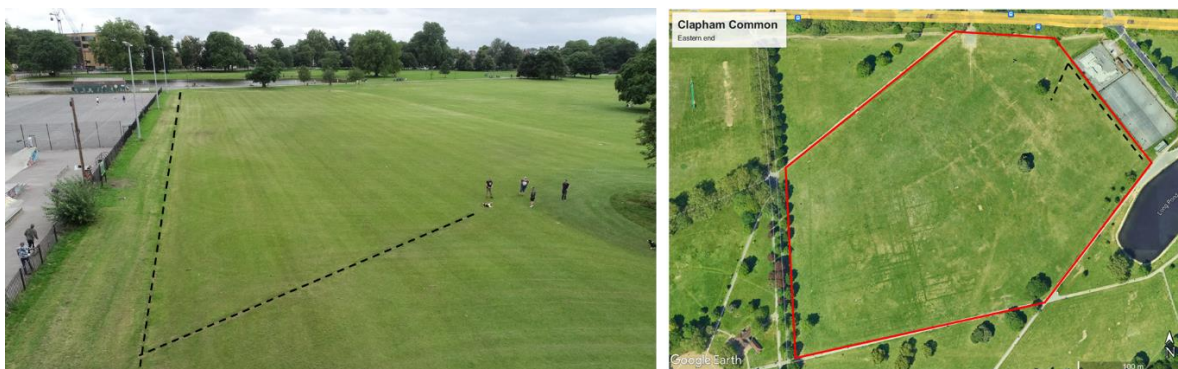
**Figure 2-5 Drain lines incorporated and, R, their approximate location**

A number of drain lines were also incorporated. Their locations are shown in the plan and aerial view from the day of the investigation in Figure 2-5. The appearance of the drain lines is shown in Figure 2-6.

These drain lines were associated with a system of 'vertical drains' whereby the pipework connected to a series of vertical columns excavated to varying depths and intended to facilitate the dispersal of water to deeper layers of the soil profile. It is assumed that linear aeration treatments, such as Earthquake, were oriented so as to discharge into these drain lines.

Being located at the base of the slope against the basketball courts to the east, the newly installed drain line will serve very effectively as a catchwater, intercepting surface runoff from the adjacent higher ground.

The western spur from this serves a less obvious purpose but will no doubt be helpful. In general, and apart from specific interception as with the eastern catchwater, pipe drains incorporated into the body of the site are unlikely to be hugely effective. This is because the great majority of the water arriving at the surface should percolate directly through to the subsoil. The exception may be in relation to an area to the south, indicated in Figure 3-1. Following the winter event of 2018/19, this area was very wet. Interestingly, the Google Earth image gives a suggestion of a linear feature in this locality, possibly an old land drain. This is an area to watch over the winter and, if a similar situation occurs, the installation of a carefully-located catchwater or similar drain may be appropriate to intercept the outpourings of this feature before they affect the wider site downstream of it.

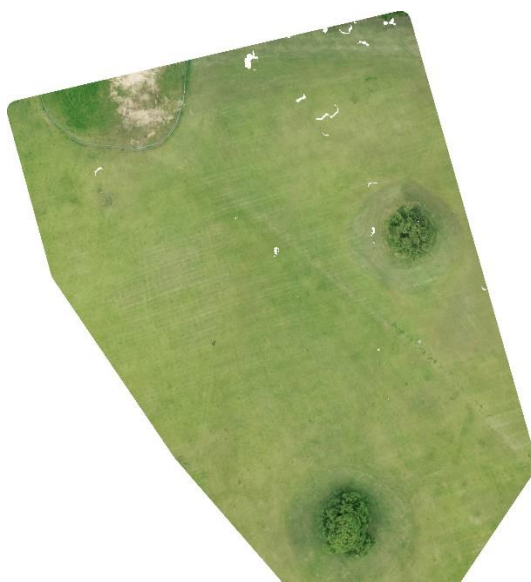
Figure 2-7 Compilation photo of eastern section of Event area

The works had resulted in a generally substantial restoration of ground cover across the site. A photograph compiled from 9 images of the eastern part of the Event area, that most intensively used, is shown in Figure 2-7 which illustrates this. The white flecks are artefacts of the compilation process.

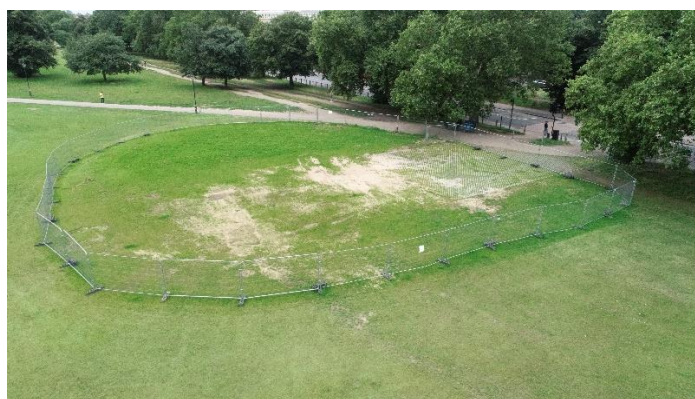
Figure 2-8 Compound area to the north of the Event area

The only area of persistent bare ground was noted in the vicinity of the entrance to the north. This had been used as a storage/compound area for the contractors undertaking the work and is shown in Figure 2-8.

Other specific issues pertaining to the site in its present state include, of course, the need to re-establish ground cover on the entrance area, something it is understood is already in hand. More generally, a lighter over-seeding would be appropriate if resources allow, with the aim of raising the average ground cover, to the east especially, from the 88 % recorded here to closer to 100 %. Such over-seeding would ideally be timed for September/October – ie on receipt of this report, when there is no need to be concerned with irrigation but when soil temperatures remain sufficiently high to facilitate successful germination.

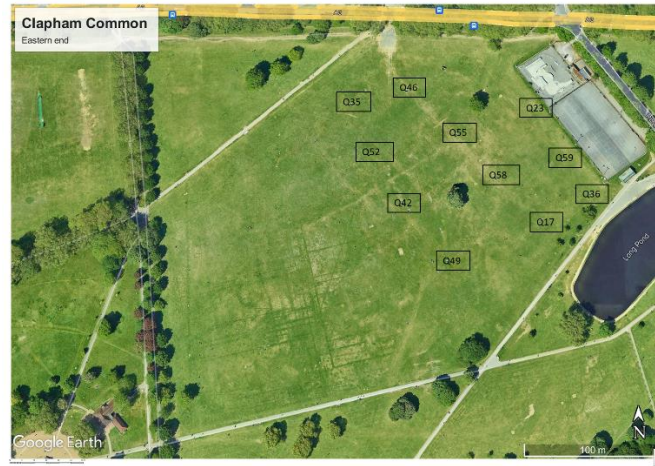
**Figure 2-9** Quadrat photo locations

Ground cover across the site was observed and noted specifically at the locations shown in Figure 2-9 (Q42, Q58 etc).

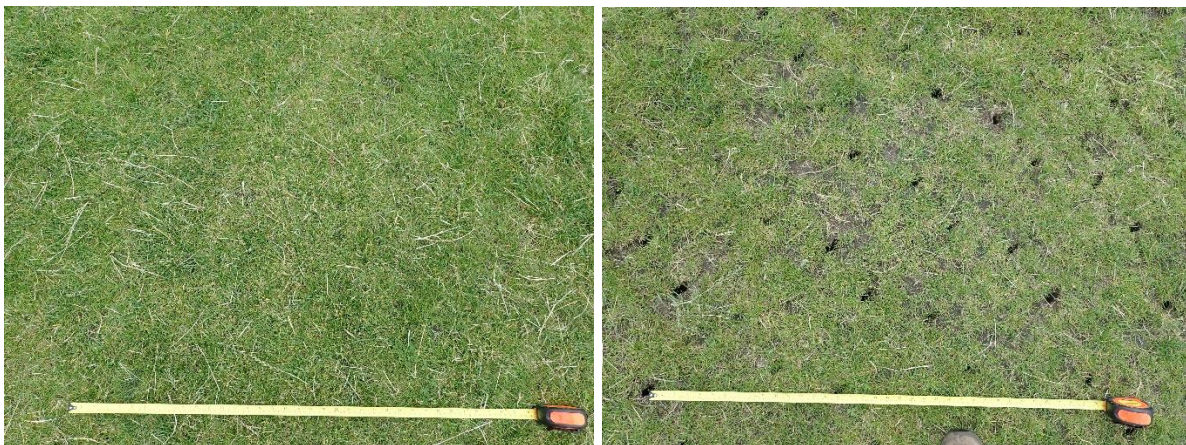
**Figure 2-10** Quadrats 35 and 55

Images of the quadrats at each of these locations are provided in APPENDIX 1 – QUADRATS. Examples are reproduced in Figure 2-10.

The quadrats showed the percentage ground cover indicated in Table 2-2. These gave an average ground cover of 88 %. In general, the shortfall in ground cover was of the form associated with recently sown grassland at the height of summer. It was noted that verti-draining had very recently been completed over some of the area.

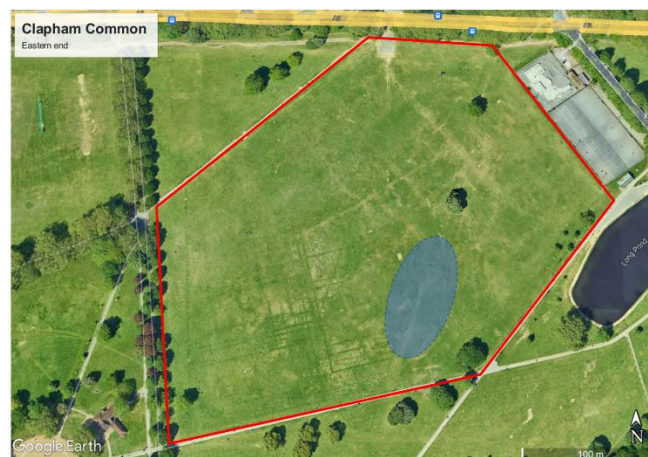
Figure 3-1 Potentially persistently wet area

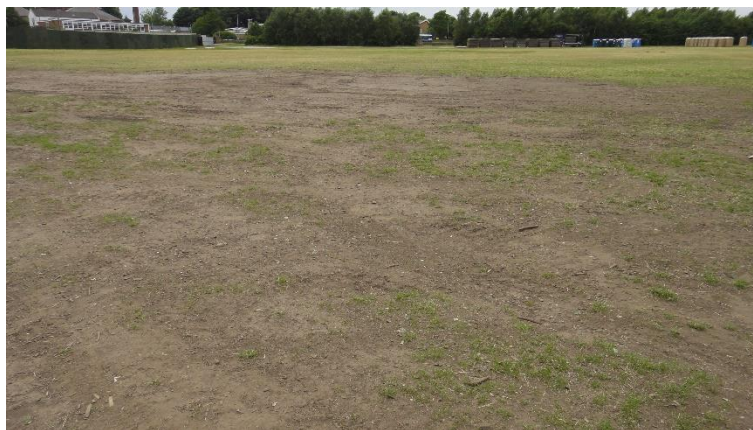
Where the ground is protected by appropriate trackway, and if the conditions remain dry throughout the period of the event, it is unlikely that compaction will be a significant problem. The most vulnerable areas will be where people congregate for longer periods, for example in front of stages and in the vicinity of the bars. In general, therefore, the laying down of as much ground protection as is possible will minimise this phenomenon. Ground protection cannot be located throughout the entire site, however, and some such disruption must be anticipated. The degree of that disruption will be related to the extent and duration of footfall taking place on them.

**Figure 5-1 Intense footfall damage on close-mown area of amenity turf (Heaton Park, Manchester)**

It follows, therefore, that the most intensive compaction relief operations will need to be carried out on those areas of the heaviest footfall. The verti-drain is undoubtedly the most effective means of relieving compaction in the aftermath of such circumstances. During the summer months, however, the ground may not be sufficiently penetrable with this machine until more moist conditions develop in the autumn. An example is shown in Figure 5-2 of a verti-drain fitted with 12 mm solid tines. Note that 18 or 25 mm tines would be more appropriate in this situation and the machine should be set to maximum heave action to achieve the greatest compaction-relieving effect.

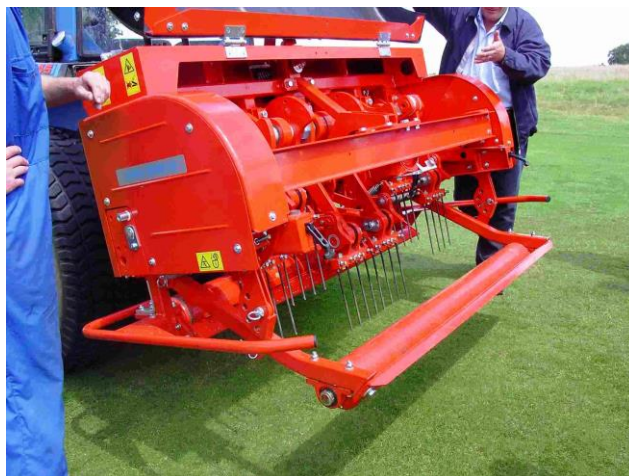
**Figure 5-2 Verti drain with 12 mm tines**

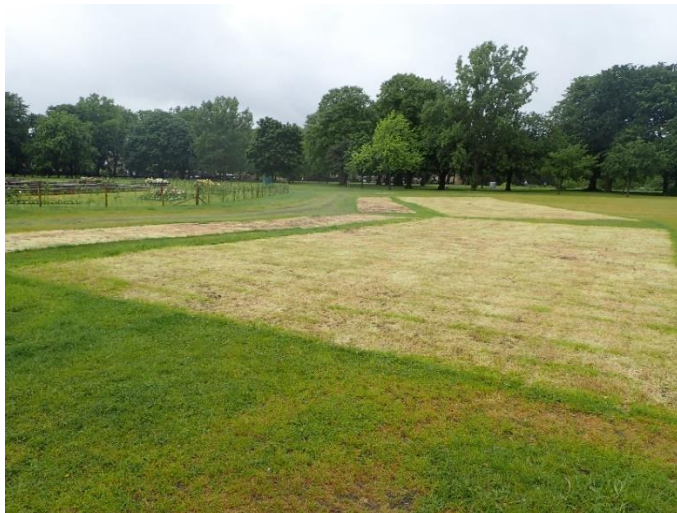
Items of ground protection itself will have detrimental consequences for the underlying vegetation, albeit mainly of a temporary nature. The extent of this is related to the exact form of the protection used, and the length of time over which it is laid down. It has been observed that where even a small gap exists between the item placed on the ground and the ground itself, the damage to the vegetation is greatly reduced. This is due, presumably, to the additional air circulation that can be achieved in the immediate environment above the vegetation.

**Figure 5-3 Ground conditions on removal of protection after about 16 days (Victoria Park, Tower Hamlets)**

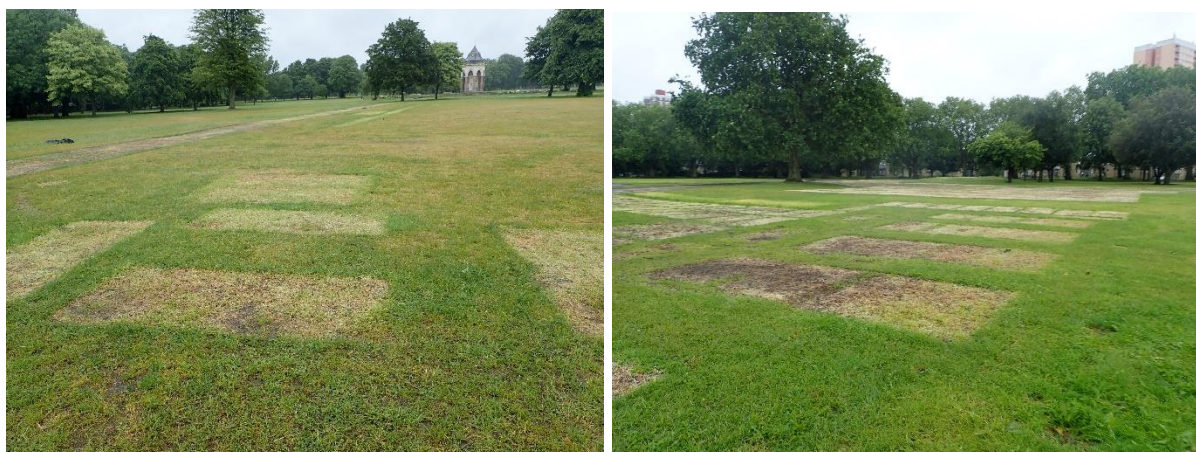
The extent of damage caused by item placement is also a function of the length of time over which it is laid down. If the event is of relatively short duration, items such as trackways and flooring may result in the weakening and etiolation of grass due to lack of sunlight rather than their death. Consequently, a full recovery can be expected to take place over most of these areas commencing as soon as the items are removed. Nevertheless, last minute laying down and prompt removal of items is to be encouraged in the interests of the ground cover.

**Figure 5-4 Localised consequences of prolonged item placement (Victoria Park, Tower Hamlets)**
