MOONWALK LONDON 2020 - WALK THE WALK AGRONOMY REPORT

23 August 2019

**MOONWALK LONDON 2020 - WALK THE WALK
AGRONOMY REPORT**

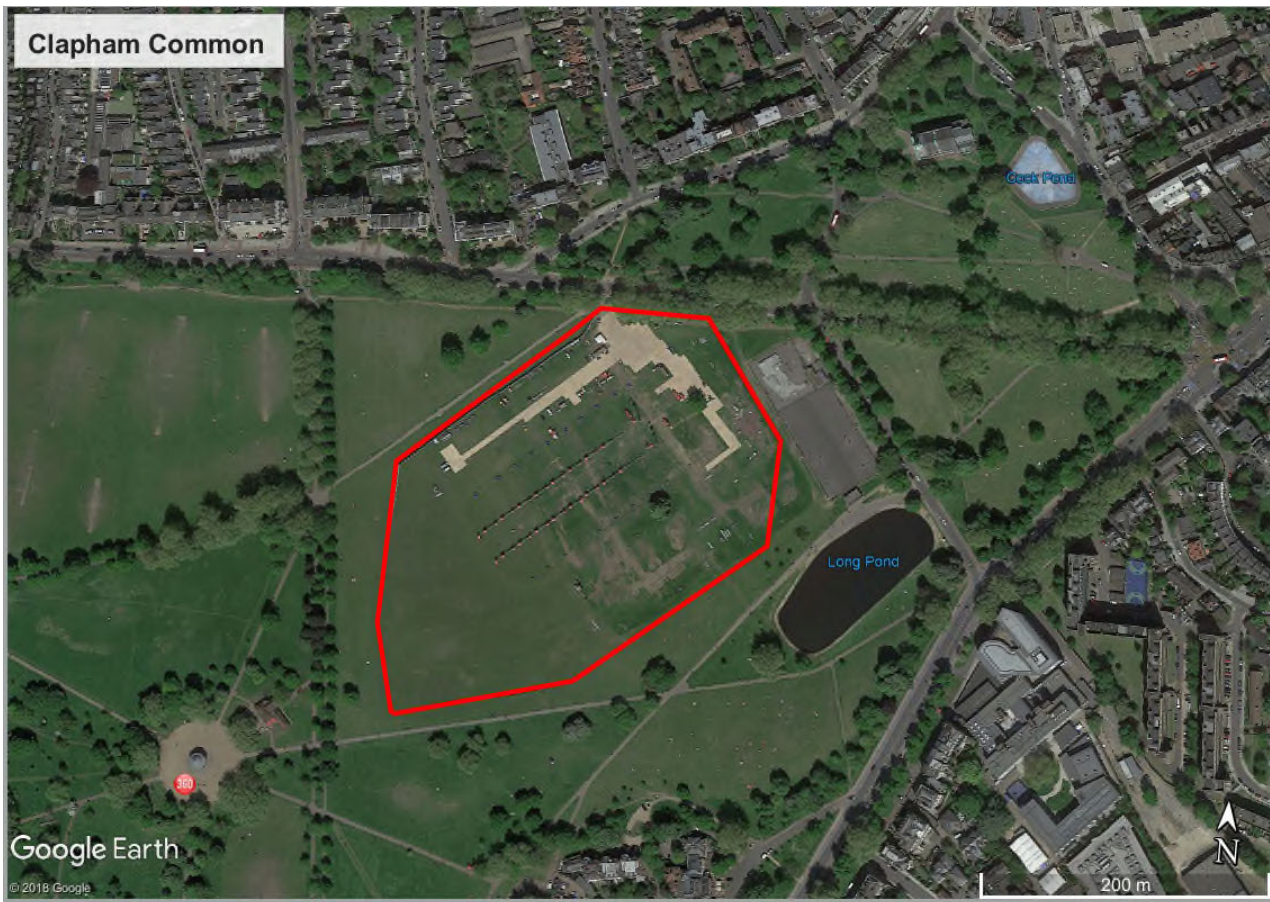
Figure 2-1 Area occupied by the Event

The Event, known as 'Moonwalk, requires the enclosure of a part of the Park shown in the Google Earth image of Figure 2-1. This represents an area of approximately 5.5 hectares.

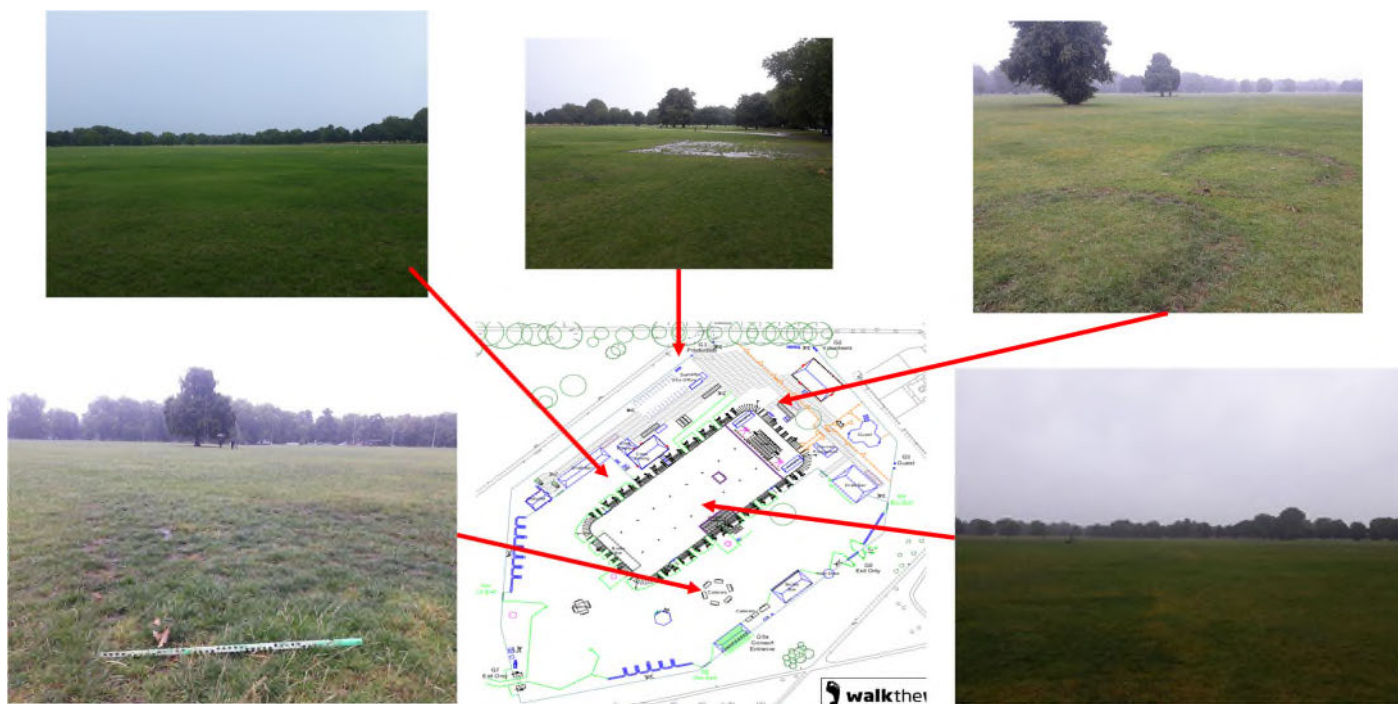
Figure 2-3 Ground cover assessment

In addition to the general observations made during the walk itself, ground cover and species composition was assessed by eye and photographed at different points over the area with example pictures shown in Figure 2-3.

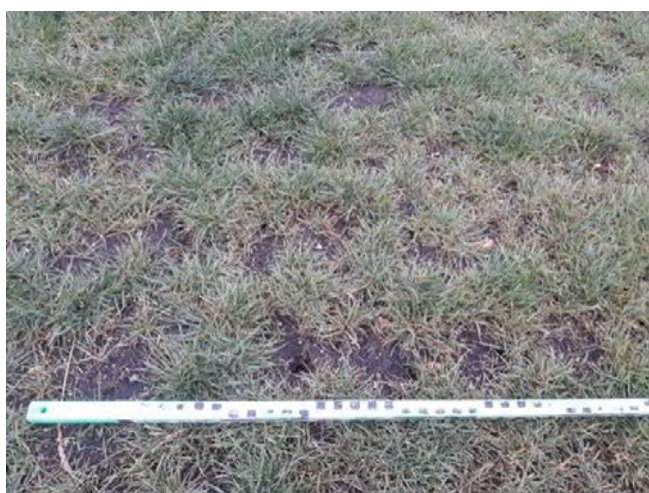
Figure 2-4 Aeration holes

The ground cover of areas subject to regular mowing were examined. In general, the ground cover was very well established and maintained. During the visit the effects of some aeration works (probably verti-draining) that had been carried out recently were noted. This suggested that the park was being maintained appropriately.

Verti-drain the site in early spring, before ground conditions become too hard to allow adequate penetration with the machine. Use the largest available tines, preferably new ones with the machine set to achieve maximum heave. Reduce forward speed to achieve the greatest density of perforation. Ground conditions must be sufficiently firm to allow this but surface disruption may be corrected if necessary by carrying out a light rolling afterwards.

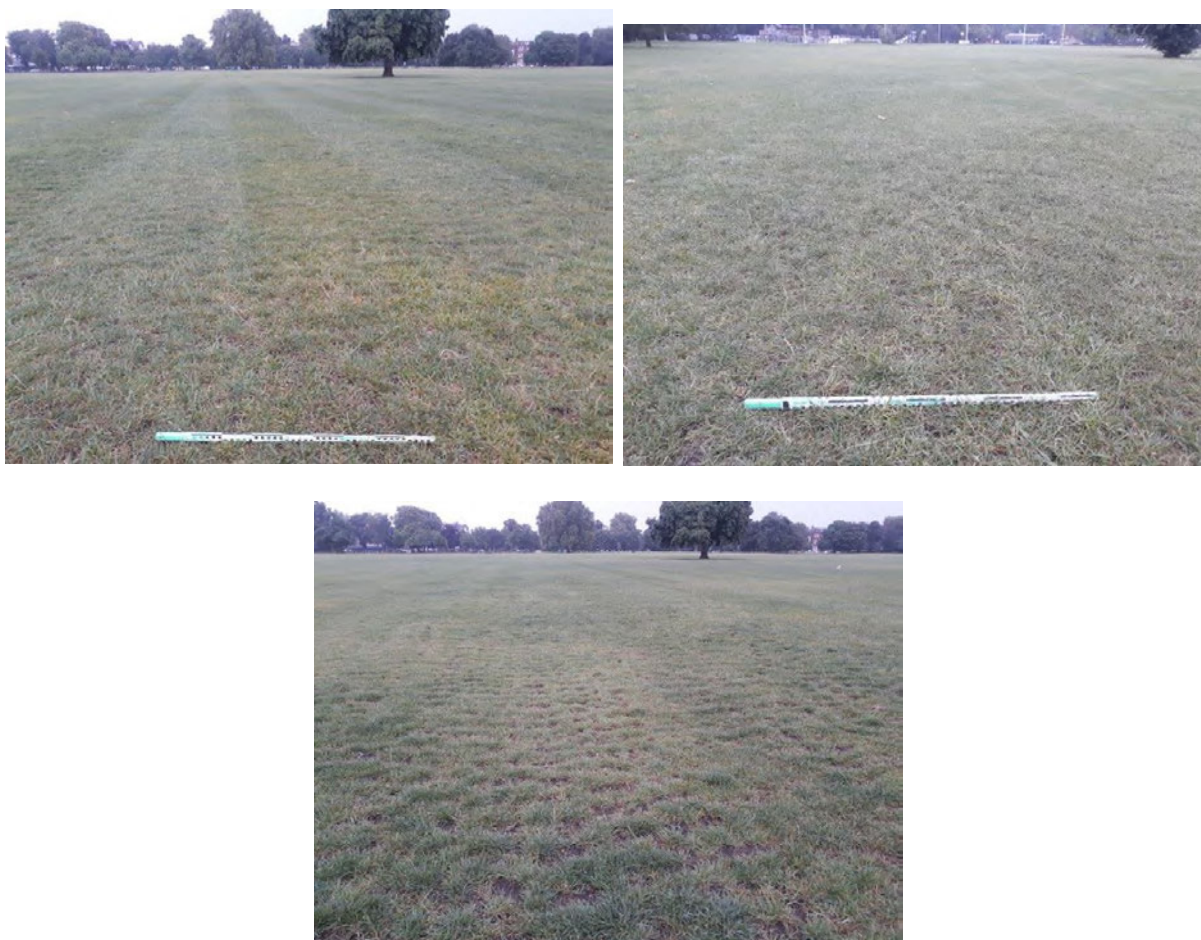
Figure 2-5 Example ground cover samples

Examples of the appearance of the sward are shown in Figure 2-5.

The great majority of the site supported a full cover of healthy grass, often growing quite vigorously, as determined by the stripes left by the last mowing operation. Some areas provided better cover than others due to different factors as footfall, water movement and retention in the soil, differing grass species, nutrient availability and so on, but in general, the coverage was good for a public park.

The species represented included perennial ryegrass which was by far the most abundant. Annual meadow grass tended to be found in the mown areas of reduced ground cover. Other species occurred in a scattered distribution across the site.

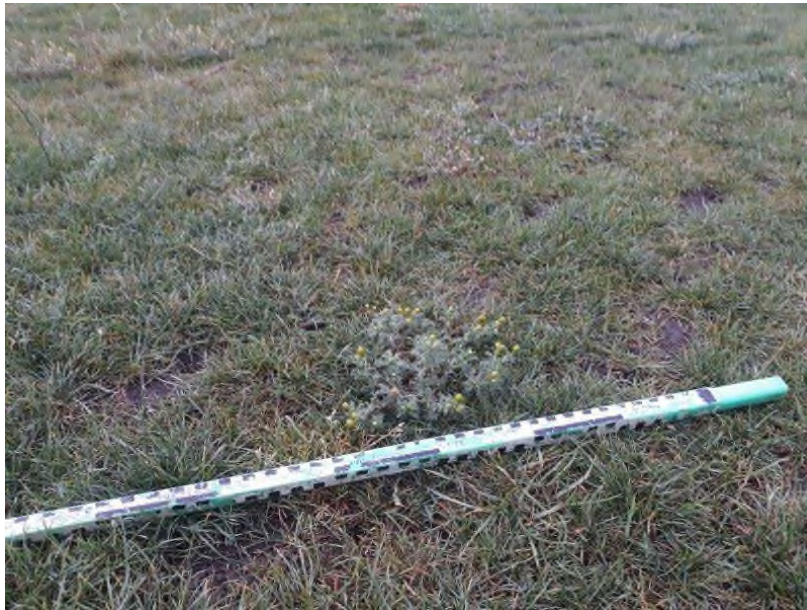
Figure 2-6 Pineapple weed

There were not many broad-leaved species and those that were found tended to be in areas where the grass cover had slightly less density. These areas were placed mostly in the southern part of park where sward density was lower. Pineapple weed (*Matricaria matricariodes*) was the most common weed found across the area

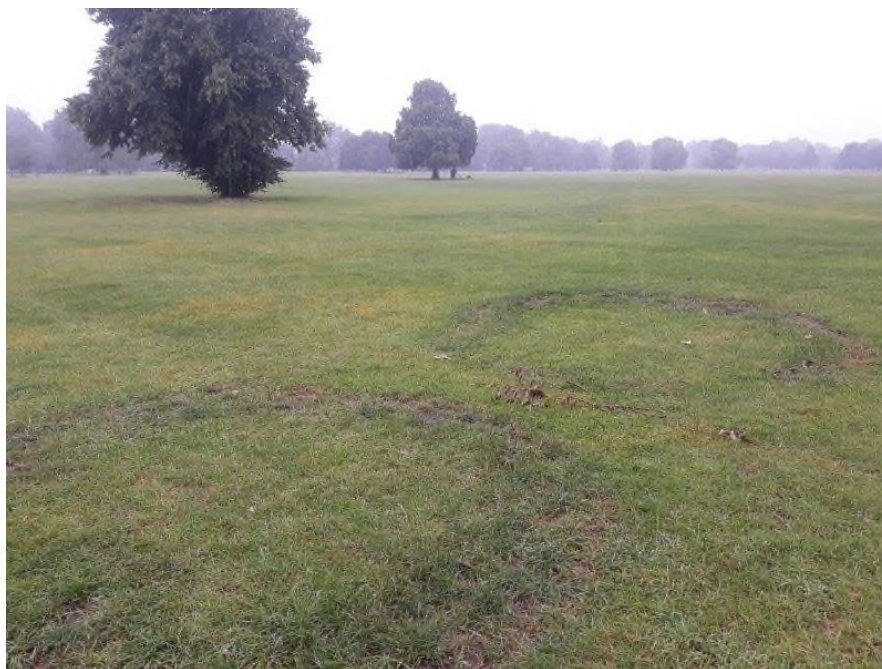
Figure 2-7 Fairy rings

Some long-established fairy rings were noted as shown in Figure 2-5. This disease, created by a fungus, is very common in old amenity grassland and pasture. There are different kinds of fungus forming such rings and these have varying degrees of impact on the turf. The effects are brought about chiefly by the water repellence which the fungus imparts to the soil and thereby prevents the grass from absorbing sufficient moisture. The consequences therefore tend to be most apparent in late summer when the soils generally are at their driest.

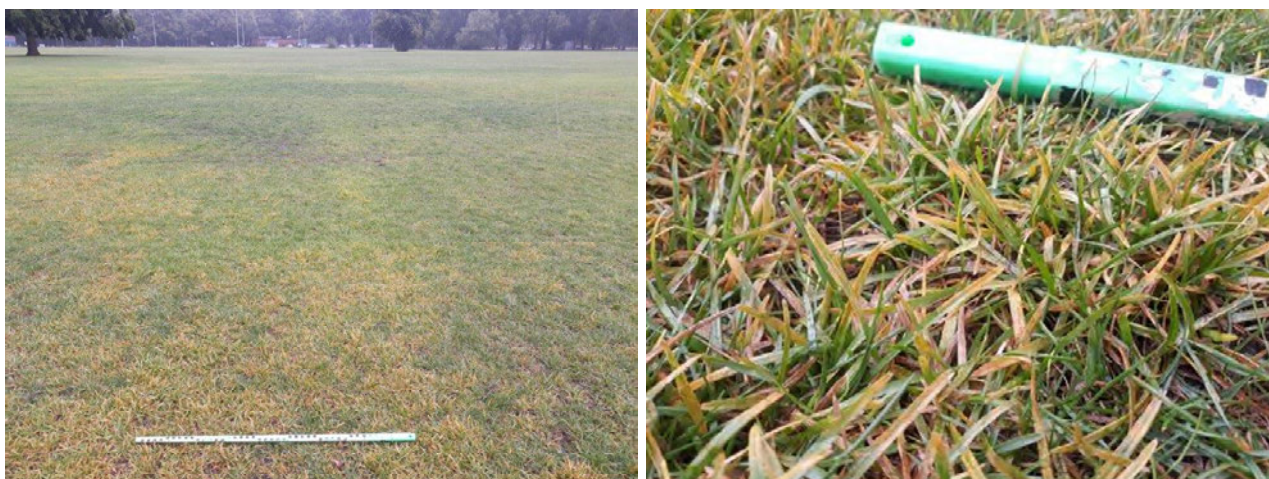
Figure 2-8 Yellow grass

There was some evidence of locally reduced growth of grass. This may be due to a variety of causes, uneven fertiliser distribution being one possible cause. The issue is unlikely to be persistent, however, and is readily resolved with subsequent fertiliser applications.

Start the growing season in mid March with an application of a 12:6:6 granular fertiliser. These are widely available and a stock should be obtained for occasional stimulation of growth during the growing season when necessary. Apply at 35 to 50 g/m².

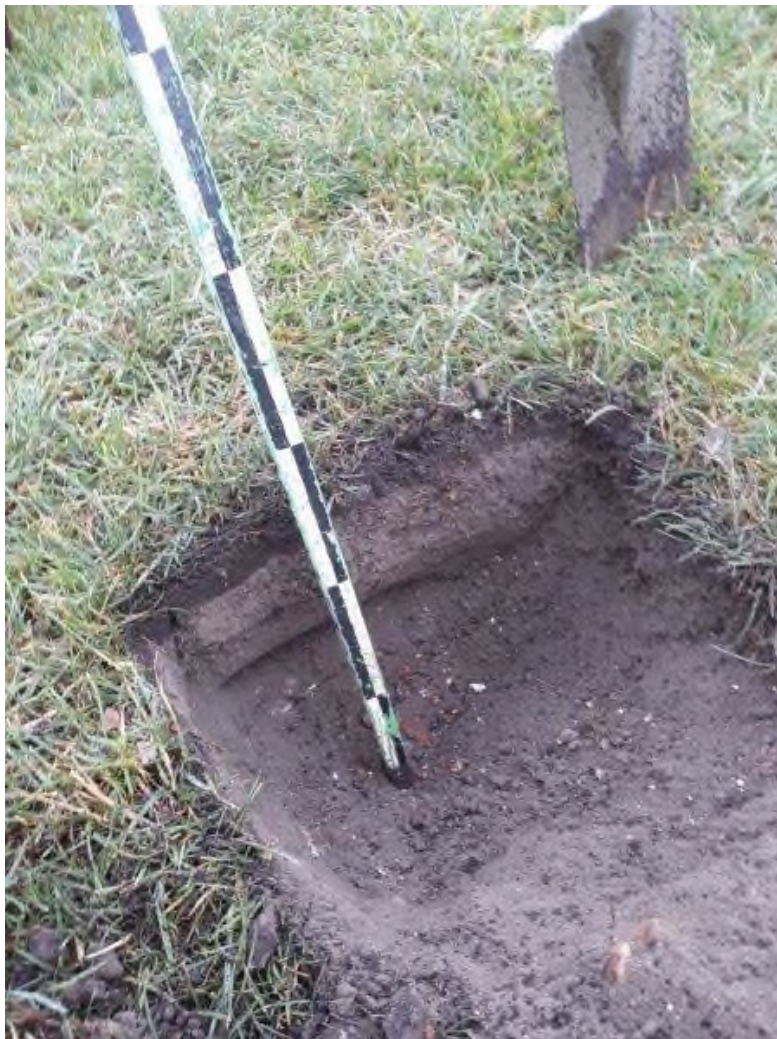
Figure 2-9 Topsoil

An excavation was carried out to determine the topsoil conditions. The soil was very compacted, and it was hard to hand excavate beyond 200 mm due to the nature of materials, a great deal of landfill with stones, bricks, etc.

The topsoil was of a generally silty texture and soil structure was poor.

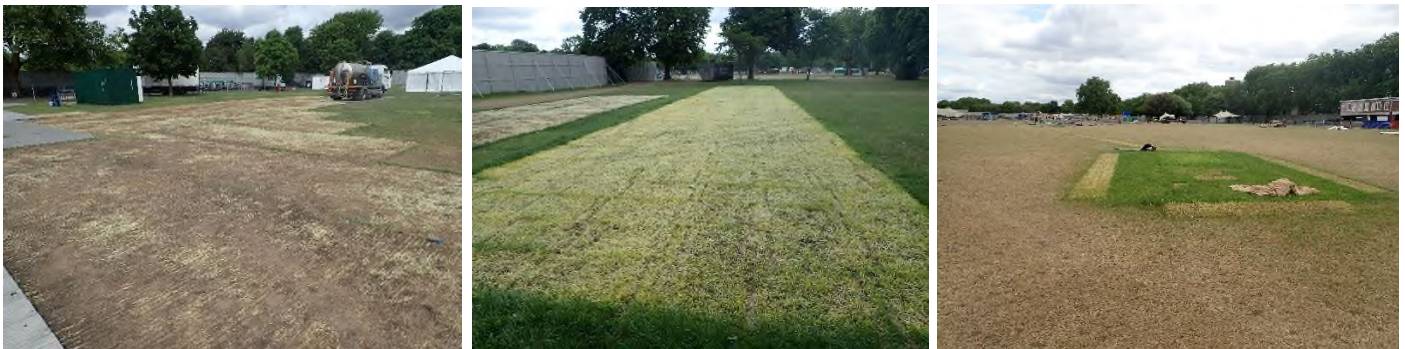
The direct connection between ground protection units and the grass prevents gases from moving in and out of the leaves and this brings about the death of grass quite rapidly. Most ground protection units are designed to minimise the area beneath them that is in direct contact with the surface but some such areas are of course essential and so the phenomenon cannot be avoided.

Direct footfall occurs to varying degrees depending now many people and how often they pass over particular areas. This variability is usually reflected in the consequences for the turf. In addition to the direct abrasion caused to the grass, the human foot is able to achieve a very considerable degree of compaction to the soil. That compaction is made very significantly worse if ground conditions are wet at the time of the event.

Figure 3-1 Different kind of damage caused by events. Damage caused by tracks (left) preventing gaseous exchange, structures and tents (middle) occluding light, and footfall (right, a grass protected area surrounded by footfall) wearing and compacting the turf

Ground protection systems that allow as much gaseous exchange to take place so that the grass can 'breathe' will be most able to reduce the extent of total ground cover loss that will otherwise be experienced beneath such structures.
